# POSTOPERATIVE IMAGES OF ANTERIOR CRUCIATE LIGAMENT RECONSTRUCTION

KK Chan, KO Cheung, K Cheung, KF Tam  
Department of Radiology, North District Hospital

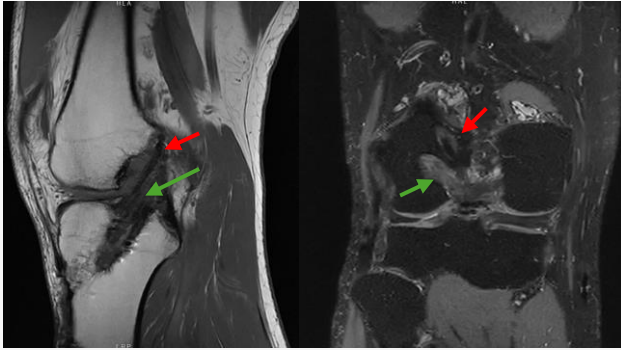
**Fig. 1** ACL reconstruction with double bundle graft. Right knee normal femoral tunnel position: AM bundle 10-11 o'clock (red arrow), PL bundle 9-10 o'clock (green arrow) on coronal plane.

Double or single bundle graft can be used for ACL reconstruction. Double bundle consist of separate posterolateral and anteromedial bundles to recreate native morphology of ACL.

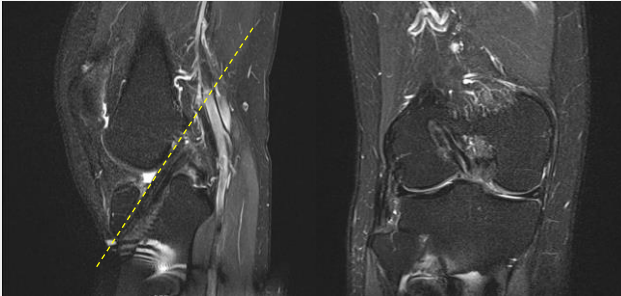
**Fig. 2** Normal single bundle graft alignment. The tibial tunnel is parallel to intercondylar roof's projected slope (the Blumensaat line; yellow dashed line). The proximal tibial tunnel opening should be posterior to the intersection of the Blumensaat line and tibia.

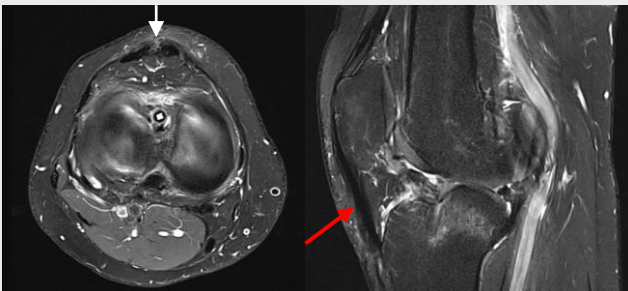
**Fig. 3** MR Images 7 months post ACL reconstruction with bone-patella-bone graft. Donor site defect at patellar tendon (white arrow) with patellar tendon thickening (red arrow)

Several types of graft for ACL reconstruction: bone patella bone, hamstring and quadriceps grafts with corresponding features in donor sites can be seen in post-op images.

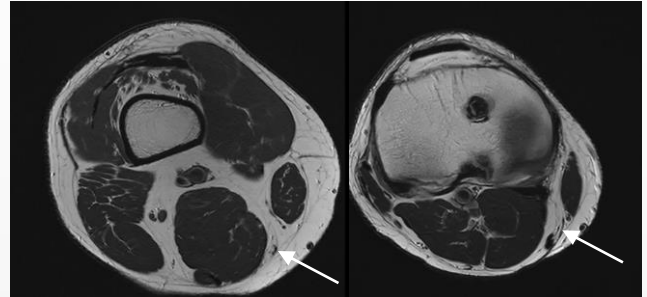
**Fig. 4** ACL reconstruction with hamstring graft. Thinning of the gracilis tendon is noted (arrows).

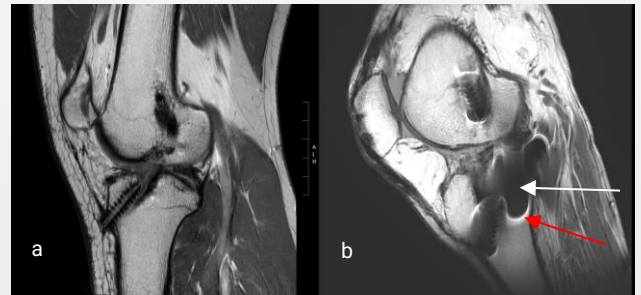
**Fig. 5 (a)** Bioabsorbable interference screw used. Its signal is low in all sequence. It has lower mechanical strength and can lead to issues like screw breakage or insufficient fixation strength. **(b)** Metallic interference screw causing artefacts with signal loss (white arrow) and signal pile-up (red arrow). Metallic interference screw provides high mechanical strength with good graft stability.

Bioabsorbable screw, metallic screw and endobutton are the common fixation devices.

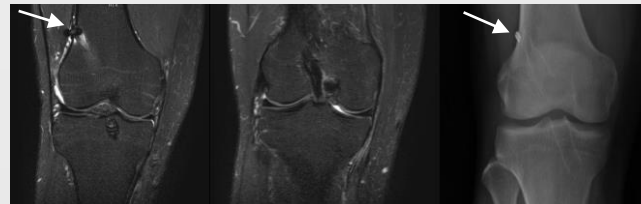
**Fig. 6** Endobutton suspending a hamstring graft. It provides cortical suspensory fixation of graft to femur.

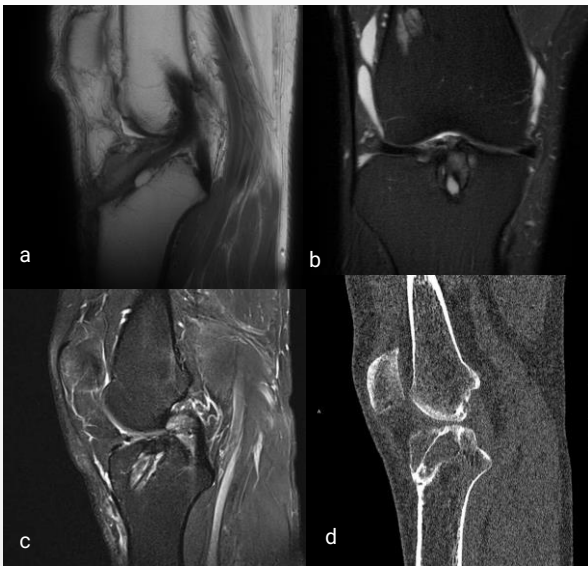
**Fig.8** (a, b) Enlarged tibial tunnel associated with ganglion cyst. (c) Enlarged tibial tunnel filled with fluid. (d) CT of patient with enlarged tibial tunnel.

Filled with fluid or cysts. It is seen usually 6 months to 24 months post-operation, more at middle third of tibia tunnel, result from motion between tunnel and graft interface. Misplaced tunnel is one of the important risk factors. Other causes include ganglion cysts, graft tunnel size mismatch.

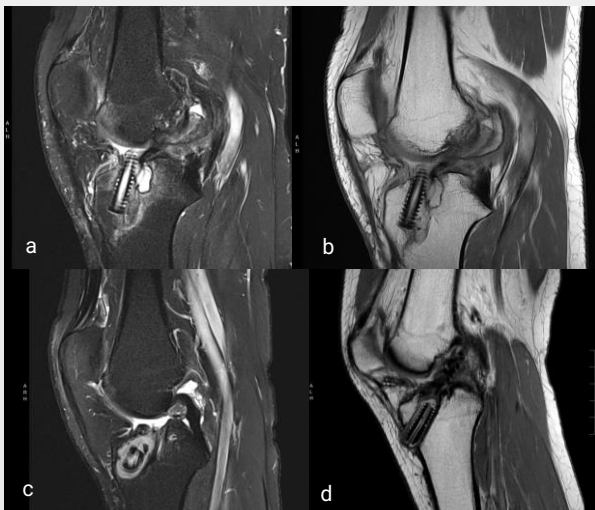
**Fig. 9** (a, b) Superior migration of tibial screw with tunnel enlargement and ganglion cyst formation. (c) Bioabsorbable screw fracture with tunnel enlargement in patient with complete ACL tear. (d) Protrusion of the tibial screw head beyond the anterior tibia cortex.

Includes fixation screw fracture and migration.

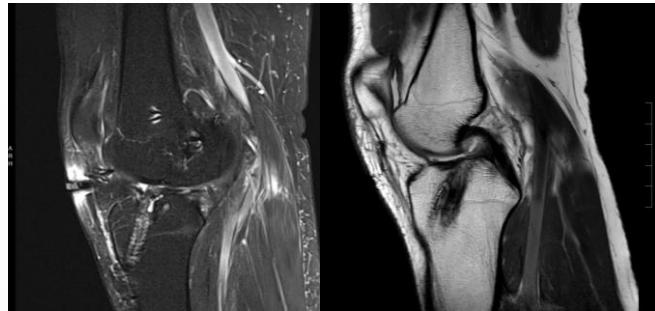
**Fig.10** Two cases of complete ACL tear with absent of intact graft fibers.

Features of complete graft tear include absence of intact graft fibers with fluid-filled defect, horizontal graft orientation or laxity, and associated marrow contusions.

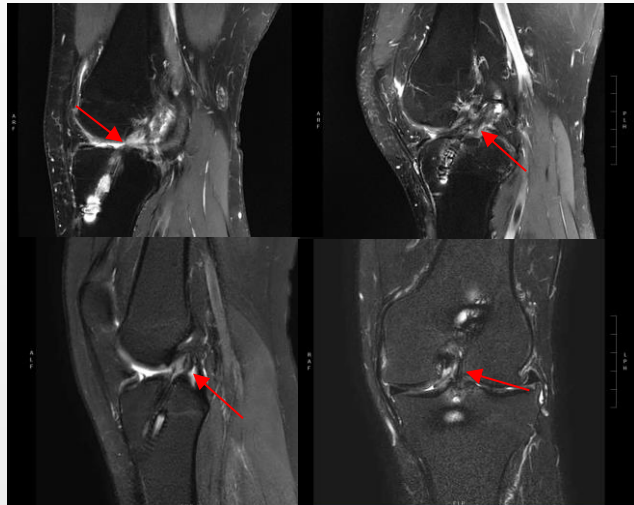
**Fig.11** Examples of partial ACL graft tear with remaining intact fibers seen.

Features of partial graft tear is suspected when a portion of the graft shows focal areas of increased signal intensity at T2-weighted images. Some intact fibers should still present. Between 4-12 months, ACL grafts may show increased signal on T2-weighted sequences secondary to revascularization and may not indicate functional failure.

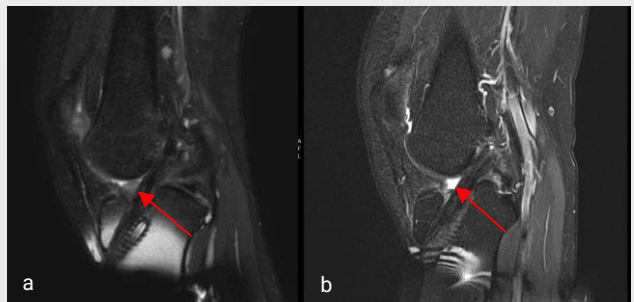
**Fig.12** (a) Patient complained of pain and clicking during knee extension post ACL reconstruction. MRI revealed cyclops lesions anterior to the ACL graft. (b) Arthroscopy resection of the cyclops lesion performed. Follow up MRI showed resection of the cyclops lesion. Patient's knee extension symptoms resolved after operation.

Scar tissue in at least one compartment of the knee joint, in and around the synovium. Cyclops lesion is the localized nodular anterior to the reconstructed ACL. It shows low to intermediate signal on T2-weighted images.

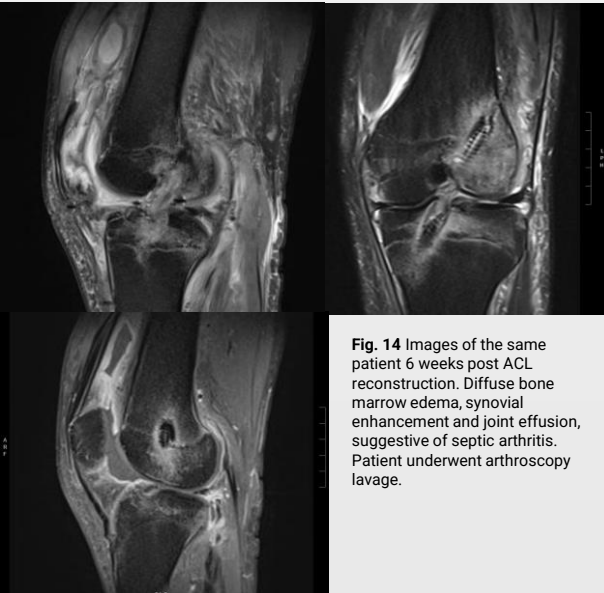
**Fig. 14** Images of the same patient 6 weeks post ACL reconstruction. Diffuse bone marrow edema, synovial enhancement and joint effusion, suggestive of septic arthritis. Patient underwent arthroscopy lavage.

The reported cumulative incidence of post ACL reconstruction septic arthritis is 0.1-0.9% . Most acute infection occurs within 2 weeks, with subacute infection occurs 2 weeks to 2 months. MR imaging findings of infection include sinus tracts, synovitis, bone erosion, marrow edema, periarticular edema and soft-tissue abscesses.

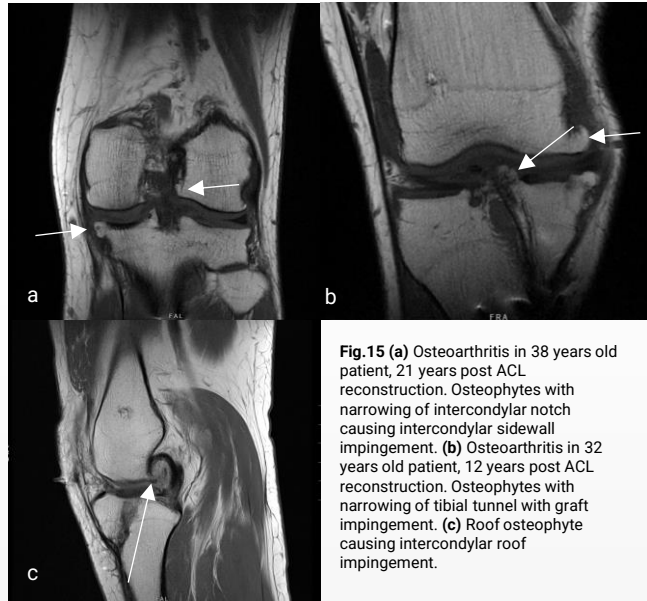
**Fig.15 (a)** Osteoarthritis in 38 years old patient, 21 years post ACL reconstruction. Osteophytes with narrowing of intercondylar notch causing intercondylar sidewall impingement. **(b)** Osteoarthritis in 32 years old patient, 12 years post ACL reconstruction. Osteophytes with narrowing of tibial tunnel with graft impingement. **(c)** Roof osteophyte causing intercondylar roof impingement.

Abnormal position of tibial tunnel relative to femoral tunnel and osteophytes formation are the two main reasons for graft impingement.

ACL injuries lead to early osteoarthritis. Patients with ACL reconstruction still experience increased progression of osteoarthritis. Osteophytes formation around the graft could cause graft impingement.
